**AFFCO IMLAY**

**ANNUAL AIR  
DISCHARGE  
MONITORING REPORT –  
2019 / 2020**

**ATH-2007010926.01**

**1 MAY 2019 TO 30 APRIL 2020**

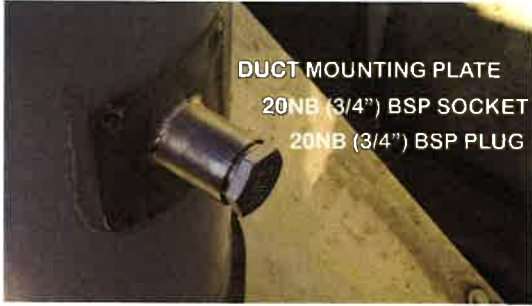
101: Flow Measuring Port Detail

- a) **Test Port Size:** Some of the ducts where vacuum is to be measured are not accessible from ground or walkway and have extended tubing to enable measurement. In 2019 the 6mm diameter tubing used for the extension tended to block. It is noted that AFFCO have since increased the size of the lines to 8mm. All extended ports were found to be working.
- b) **Location of Test Ports:** In 2019 some of the vacuum test ports were located downstream of flow adjusting slide valves (Ports 5, 6, 7, 8, and Ground Meal Bin (west)). Work done to provide monitoring ports upstream of the slide valves (i.e. on the equipment being monitored side) is acknowledged. In a few cases it is not practical to achieve this due to the proximity of the slide valve to the equipment. In some cases the slide valve is near an open hatch (photo

| 37 | Separators - solids conveyor flow measuring ports | New type photo 101 ports needed at locations 12f and 16f in Fig 1. See report section 7 (k) on page 14. | |

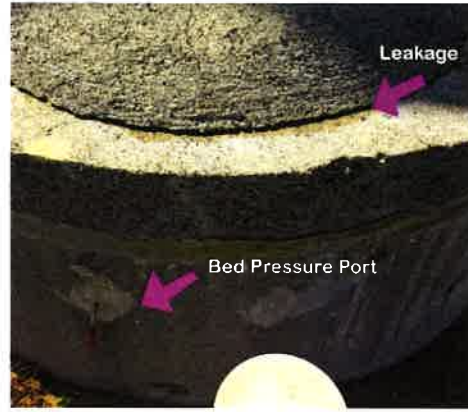
105: Covered Biofilter Sump

- a) At the downwind side of the covered biofilter a dry meal odour was recognized. An assessment on Intensity and Hedonic tone rated it  $I = 3$ ;  $H = -1$ . The sump was well sealed but there was very weak leakage at the location shown in photo 105 – this is not an issue but needs to be watched for further deterioration.
- b) Covered bins of dry blood stored outside were emitting some odour but could not be sensed further than 5m away.

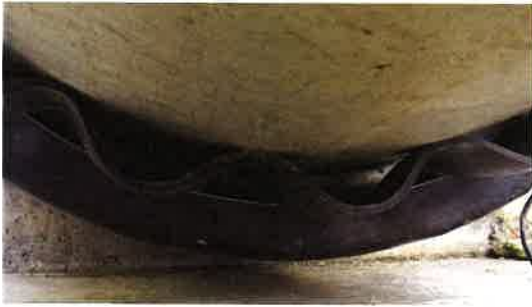
102: Fan 14.1 Discharge Duct Seal

In 2019 a significant leak was found downstream of the fan 14.1 where the stainless steel duct joins the concrete pipe. It is noted that a permanent full circumferential skirt secured by tensioned bands has now been installed (Photo 102) to withstand the vibration from the fan. There was no leakage at this location but it was observed that the thick rubber sheet used was not able to accommodate the difference in pipe diameters and has gathered as seen in the photo. Packing (not visible) may also have been used but there is potential for leakage to occur inside the tensioning bands at the bottom. Regular inspection for leakage is needed and if necessary a tapered skirt of thinner coated fabric installed to achieve the seal.

| 11 | Fan 14.1 Discharge Duct Sealing | Stainless steel discharge duct from fan 14.1 frequently leaks at junction with concrete pipe due to inability of flexible sealant to cope with vibration. A circumferential sealing skirt secured with tensioned bands each side of the joint is needed to provide a more permanent seal. | Install a tapered skirt of thinner coated fabric to achieve the seal. | <p>Refer to New Ports #4 &amp; #5</p> |

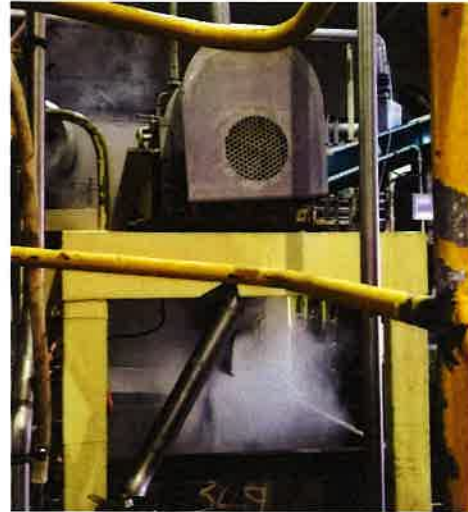
106: Blood Decanter Centrifuge

- g) **Blood Decanter (Port 5):** As reported in 2019 significant steamy discharge occurs from the conveyor under the blood decanter. There is good vacuum in the larger 150mm diameter extraction duct leg but inadequate headspace in the conveyor to draw the vapour from the decanter along to the duct. Another leg of 76mm dairy tube has been added to collect vapour at the east end of the conveyor but this is too small for the vapour flow. Either a larger conveyor or a larger extraction duct to the conveyor east side is required. Alternatively, a lightweight raiseable hood with flexible duct connection to the extraction system could collect much of the vapour.

| No | Item | Issue | Responsibility | Target Date |
|---|---|---|--|---|
| 3 | Blood Decanter | Air extraction is inadequate to collect vapour emissions. Either the conveyor is too small i.e. not enough headspace for vapour transport along the screw to the larger extraction duct, or the 76 mm diameter dairy tube duct needs to be increased in size. Size of conveyor may be determined by specific blood properties requiring the conveyor to be small. | Port 5:- Extraction inadequate. If existing decanter conveyor is to be retained a raisable hood with flexible duct connection to the extraction system appears to be one solution. | Post COVID-19 |

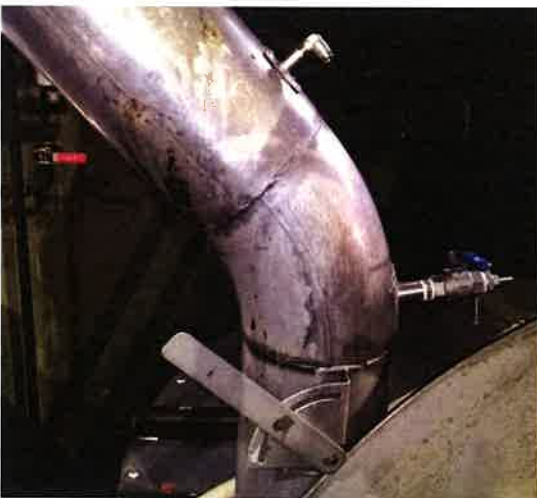
104: Separator Feed Tank Ports 14 – 14a

- o) **Decanter and Separator Liquid Feed Tanks (Port 14):** A new flow measuring port (14f, fig 1) has been installed in the air extraction Y-leg to the separator feed tank. The legs to both tanks have a butterfly valve at entry to each duct which are set at 45°. Vacuum measurement ports in both legs were reading the same so it has been assumed that the measured flow at 14f indicates the same flow in the decanter tank leg. Total flow in both legs is determined by the slide valve above where the legs join. Flow measured on 13 Feb 2020 was 1800 m<sup>3</sup>/h in each leg. The recommended flow in the consent application was 300 m<sup>3</sup>/h for each tank. The temperature of the air at the time of measurement was 63°C but this rises to above 90°C during processing.

| No | Item | Issue | Responsibility | Target Date |
|---|---|---|--|---|
| 2 | Liquid phase tanks | Extraction vacuum is so high too much vapour is being removed. A working slide valve in the common leg is needed to reduce the vacuum in the tank headspace or alternatively some additional extraction air could be drawn from the sump, breaker and IMD belt area nearby to moderate the vacuum. | Further adjustments to flows to be made by John Vickerman. | Post COVID-19 |

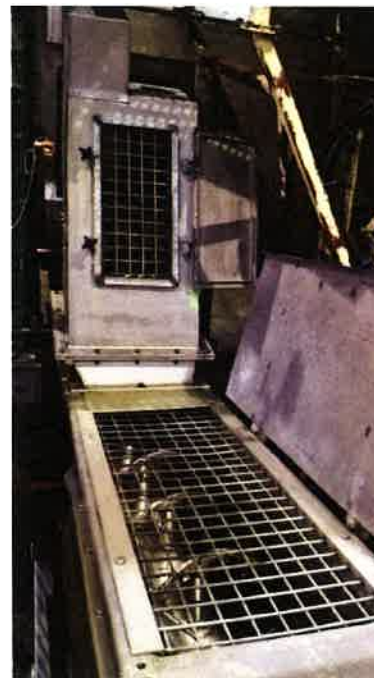
107: Drainer Conveyor Hatch

- f) **Preheater Discharge (Port 4):** In normal operation the hatch (photo 107 in the background) is normally open. As there is no port below the slide valve a 6.5mm hole in the side of the connecting box would enable consistent vacuum measurement. Vacuum above the slide valve was 200Pa. Airflow through the hatch and partially up from the open drainer conveyor hatch seen in the foreground in photo 107 was 1250 m<sup>3</sup>/h. This exceeds the recommended flow of 400 m<sup>3</sup>/h in the consent application but is considered a good flow in the interim.
