AFFCO IMLAY

**ANNUAL AIR
DISCHARGE
MONITORING REPORT –
2020 / 2021**

AIR DISCHARGE PERMIT:-
ATH-2007010926.01

1 MAY 2020 TO 30 APRIL 2021

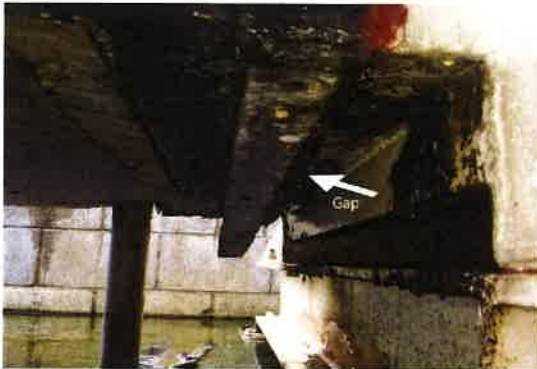
to the fan – the airflow at the leak (caused by loss of fasteners at the bottom seal clamping bar) could easily account for the flow difference.

It is noted that AFFCO did make a good effort to seal the stainless-steel transition section between the fan 14.1 outlet and the concrete pipe. From an outside view the issues stem from the poor design of the transition section:

101: Fan 14.1 outlet transition duct seal leak

This detail is mentioned because it is recognised that the issue is not an easy fix. It is critical for odour control that positive pressure ducting downstream of the fan does not leak. Having to shut down the plant to fix such a leak can also be difficult when processing capacity is critical. It is fortunate that the present leak cannot be sensed beyond around 50m downwind but a greater leak would not be so confined. It is recommended that serious consideration be given to a robust solution.

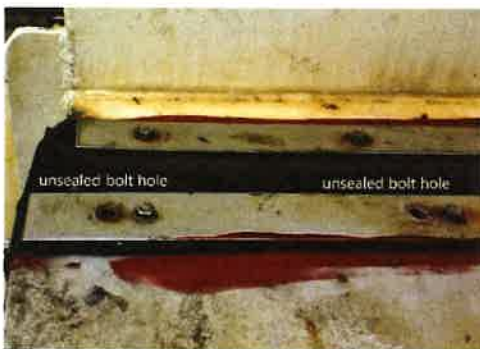
102: Fan 14.1 unsealed old open bolt holes

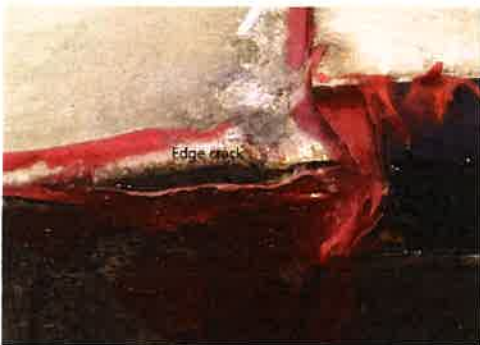
103: Fan 14.1 outlet transition duct cracking

ODOUR CONTROL SYSTEMS - 2021 ACTION LIST					
No	Item	Issue	Photo	Comments	Actions Taken
2021-3	Fan 14.1 Discharge transition duct crack sealing	See photo 103. The crack is currently well sealed but likely to open with ongoing fan vibration. Ongoing vigilance for leaks between fan and biofilter is needed.

<i>Supervisor - Mike Rennie - advised to monitor during daily monitoring checks. Completed March 2021</i>
2021-4	Driers Discharge Conveyor air extraction duct entry box	See photo 119. Pressure and flow measurements indicate that a bridge of meal must be almost completely blocking the duct below the slide valve. Removal and replacement of the slide valve makes no difference.

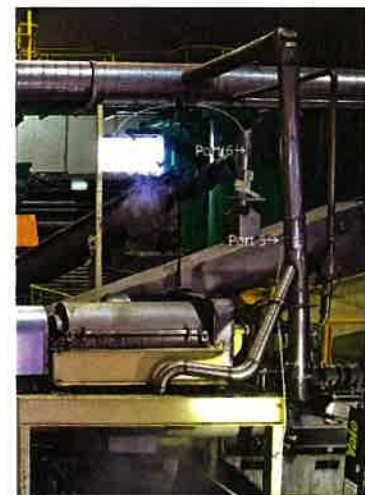
- g) **Blood Decanter (Port 5):** See photo 107. As reported in 2019 and 2020 significant steamy discharge occurs from the conveyor under the blood decanter. It appears there is inadequate head space in the conveyor under the decanter to allow air at the conveyor discharge points to be drawn in and along to the 150 mm diameter extraction duct leg. The added leg of 76mm dairy tube was plainly an attempt to capture vapour from the conveyor east exit but is too small for the vapour flow. It is recognised that the decanted blood conveyor may not be able to be modified due to the nature of the blood and that the previously mentioned raiseable hood for extraction would not be simple given the need to frequently move bins in and out. There are various options around the issue. It is assumed they are being considered. In the meantime, fortunately, there does not seem to be any significant adverse odour associated with the steam emission.

107: Port 5 - Blood Centrifuge

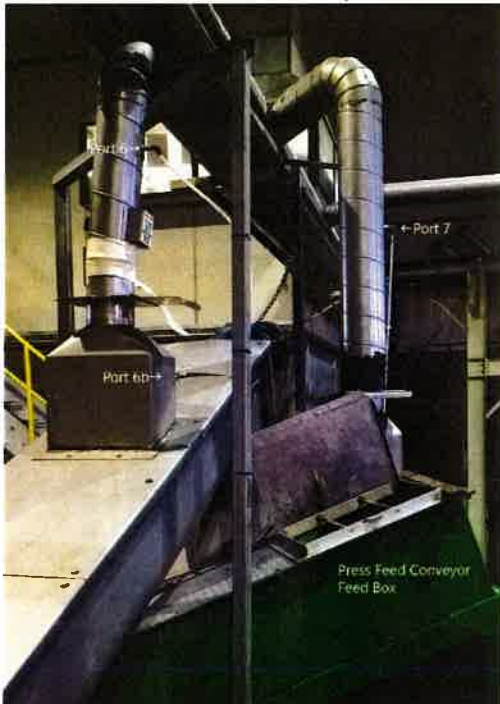
- h) **Drainer Conveyor (Port 6):** See photos 109 and 124. Port 6 is located above the slide valve and the small hole (6b) in the side of the conveyor headspace extraction box has been used to measure vacuum below the slide valve. The air flow in the duct of Port 6 largely comes from air being drawn in the 'Drainer Conveyor Inlet Screen' labelled in photo 124. The headspace vacuum at 6b was 104 – 106 Pa and at Port 6 was 194- 196 Pa. In the absence of a flow measuring port in the duct the air flow in was measured at the screen shown in photo 124 and found to be 1100 m³/h. This is well above the recommended 200 m³/h but is needed to capture vapour below the screen at the feed end of the conveyor when the preheater discharged material is hot.

109: Ports 6 and 7

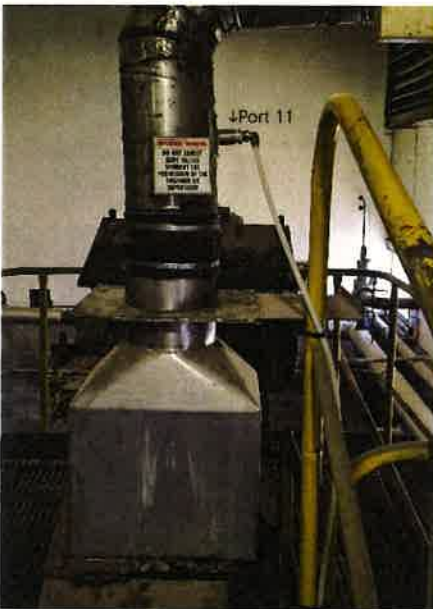
115: Port 11 – Inlet conveyor to Driers

ODOUR CONTROL SYSTEMS - 2021 ACTION LIST					
No	Item	Issue	Photo	Comments	Actions Taken
2021-5	Driers Feed Conveyor Air Extraction Duct	See photo 115. Corroded opening at base of air extraction intake box below the slide valve.

Can the opening be closed? Is the corroded slot used to check whether solids are moving in the conveyor or not? If so can a hinging flap cover the opening? Desirable to maintain slightly more vacuum in conveyor air space if possible mainly relating to what is happening at the bottom (upstream end) of the conveyor.	Completed 29.04.21
2021-6	Solids Discharge Conveyor press - decanter	See photo 122. Open slot draws in 130 m ³ /h air. A 2020 photo of the same equipment does not have the gap. Has the conveyor cover plate been intentionally assembled in the wrong position? Is this slot used to view movement of solids in conveyor? Can the slot be covered?

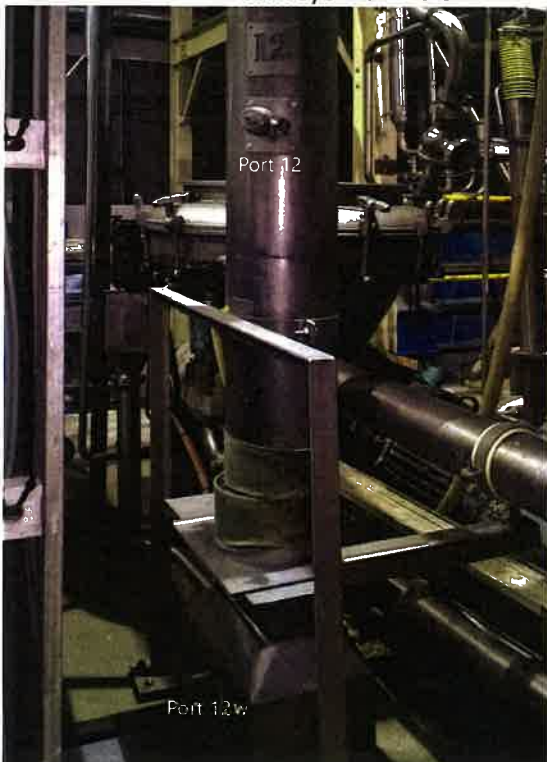
- k) **Tallow Separator Discharge Chambers 3x (Port 9) and Decanter Solids Discharge Conveyor (Port 12):** Port 12 is seen in photo 116 and Port 9 in photo 112. Port 12 is above the slide valve to the decanter solids discharge conveyor below. New port 12w has been provided to enable consistent measurement of vacuum head space in the decanter solids conveyor. As illustrated in Fig 1 the extraction duct from the separator discharge chambers (port 9) is connected to the same duct port 12 is in and up to the air extraction manifold above. The swivel Pneufit fitting at Port 9 was found blocked. When cleaned out the vacuum was typically 25- 55 Pa. Depending on what the separators are doing there can be quite a bit of variation. Vacuum at port 12w was 50 – 65 Pa; above the slide valve at port 12 was 220 – 230 Pa. The measured air flow past port 12 was 150- 200 m³/h but in preliminary fluid flow modelling using the known data, it should be higher given the duct size and the static pressures. The recommended flow in the consent application for the decanter solids conveyor was 800 m³/h but this also includes flow in duct 12e. The current extraction is adequate but greater flow from the decanter solids conveyor is required and this can probably be provided through duct 12e. The adjustment to be made is complicated by the separator extractions and more measurement and calculation needs to be done to clarify what is happening.

116: Ports 12 and 12w

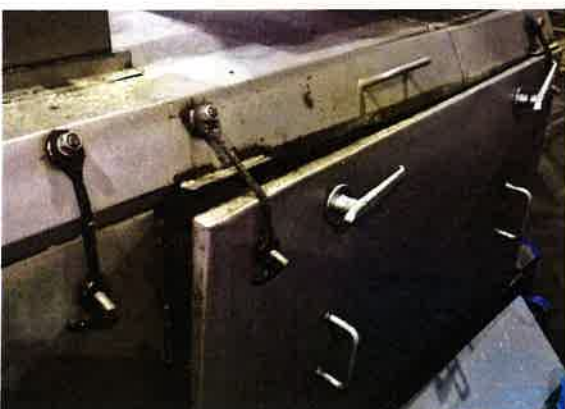
2021-10	Press west side cover panel	See photo 123: Cover panel has warped and rubber tie too weak to hold panel closed.	Other (east) side of press is operated with no panels closing the side but air extraction is sufficient to capture press vapours. Although the panel in the photo covers the same airspace (surrounding the press screw) some emission is occurring through the gap seen in the photo. A new rubber tie and fully closing door would assist containment of adverse odour.
2021-11	Wet-side air cooling heat exchangers HX1 - HX3	Following on from previous issues 2020-26 and 2020-30 a check of the top plenum of the exchangers is still to be made. Measurement of static pressure at the top of the exchangers is still wanted so capped ports need to be free to be opened for measurement.	
2021-12	Odour Management Plan OMP Procedures OMP 002 to 006 and RMF008	Following Issue 1 in March 2018 some details need revision arising from developing knowledge and practical working of some aspects.	Kupetech offers to suggest changes for consideration.

123: Press cover panel – west side

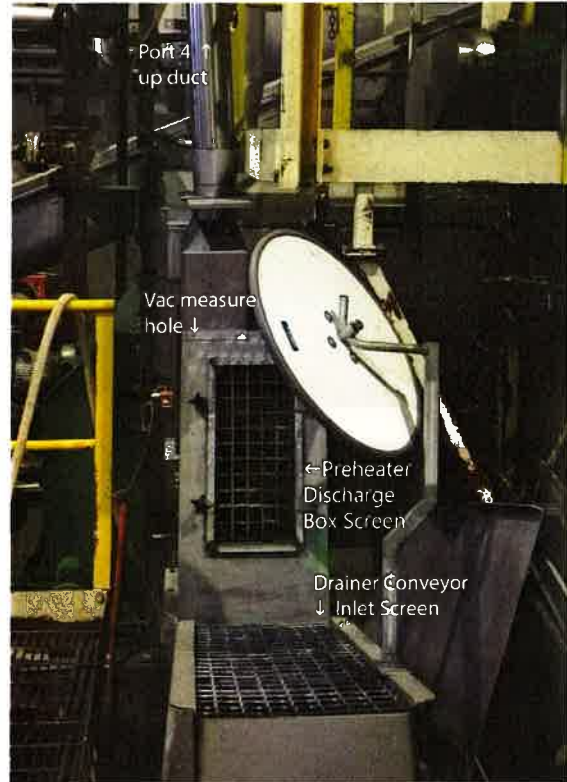
124: Preheater outlet box and drainer conveyor feed end extraction air inlets
