**AFFCO IMLAY**

**ANNUAL AIR  
DISCHARGE  
MONITORING REPORT –  
2018 / 2019**

**AIR DISCHARGE PERMIT:-**  
**ATH-2007010926.01**

**1 MAY 2018 TO 30 APRIL 2019**

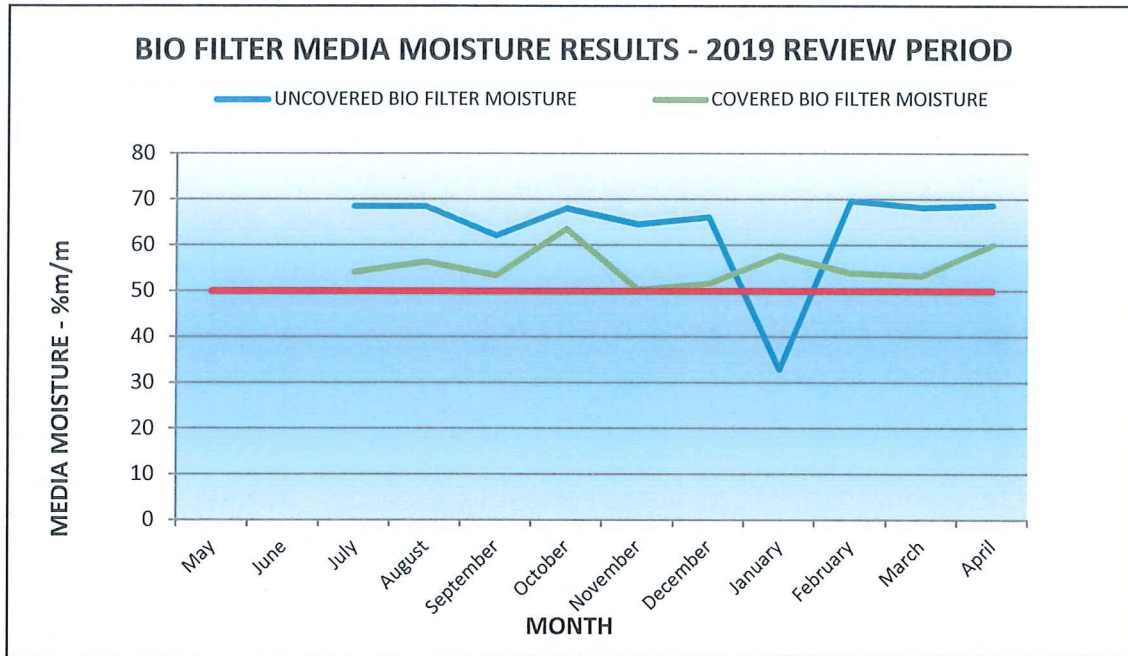
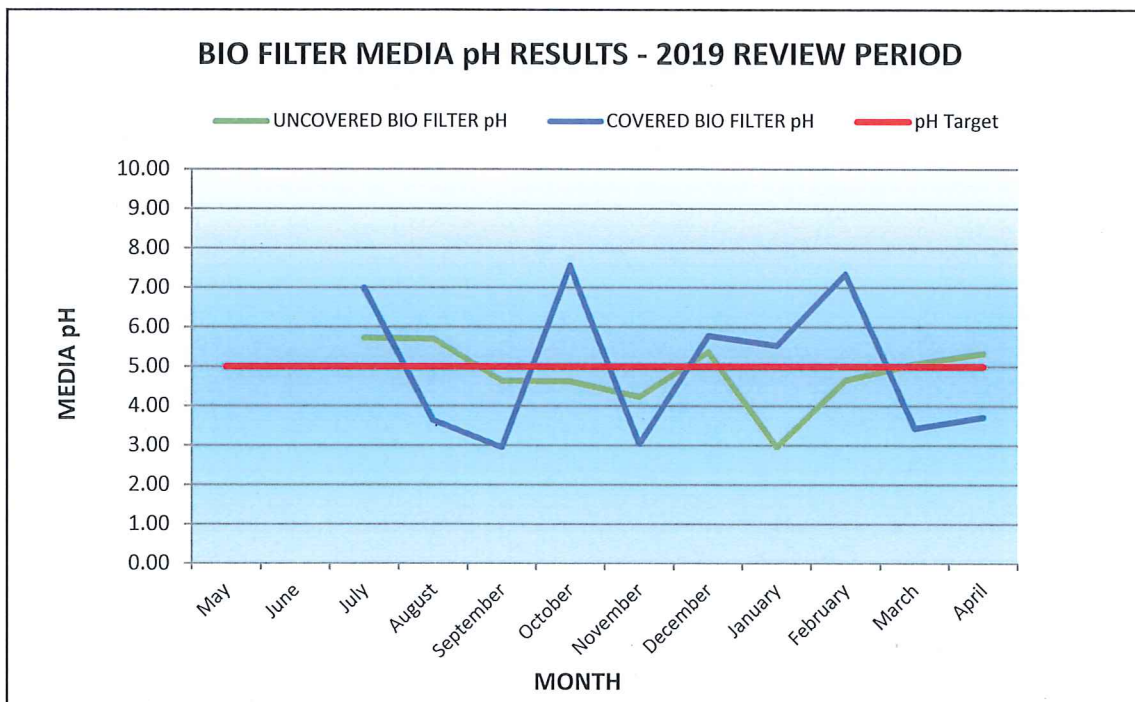
Bio-Filter Moisture and pH Graphs for the report review period:-

**Outcome:-** pH levels obtained via Asurequality testing are very inconsistent. The results do not match that of KupeTech findings (Refer Appendix 3 – KupeTech Report). Further investigation required.
