**AFFCO IMLAY**

**ANNUAL AIR  
DISCHARGE  
MONITORING REPORT –  
2019 / 2020**

**ATH-2007010926.01**

**1 MAY 2019 TO 30 APRIL 2020**

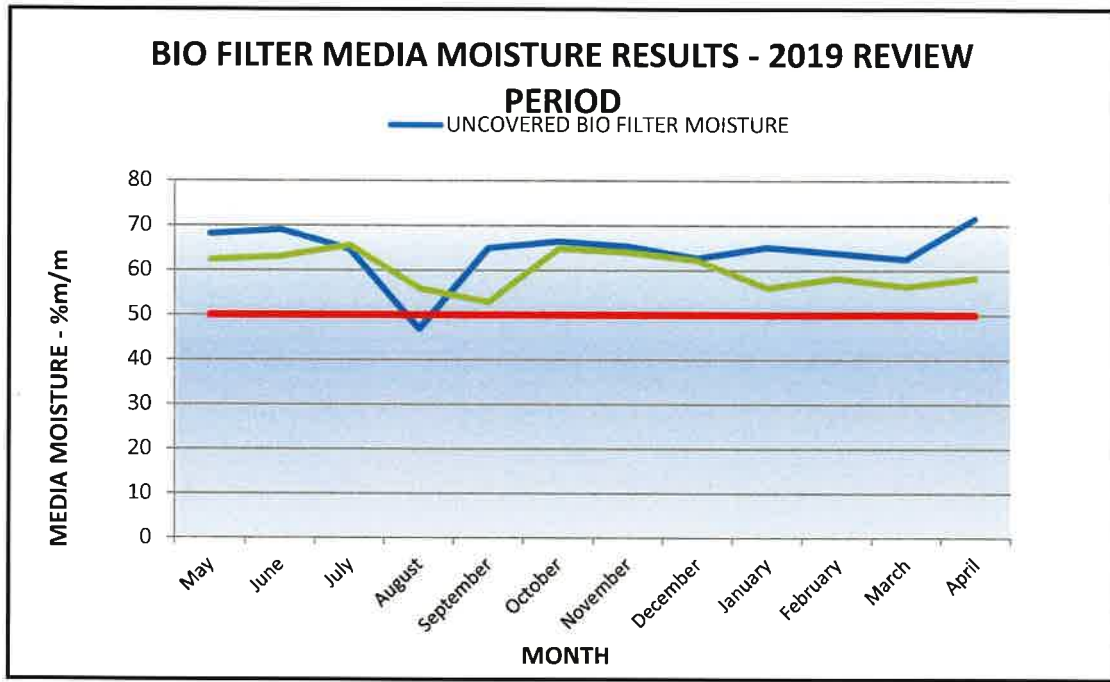
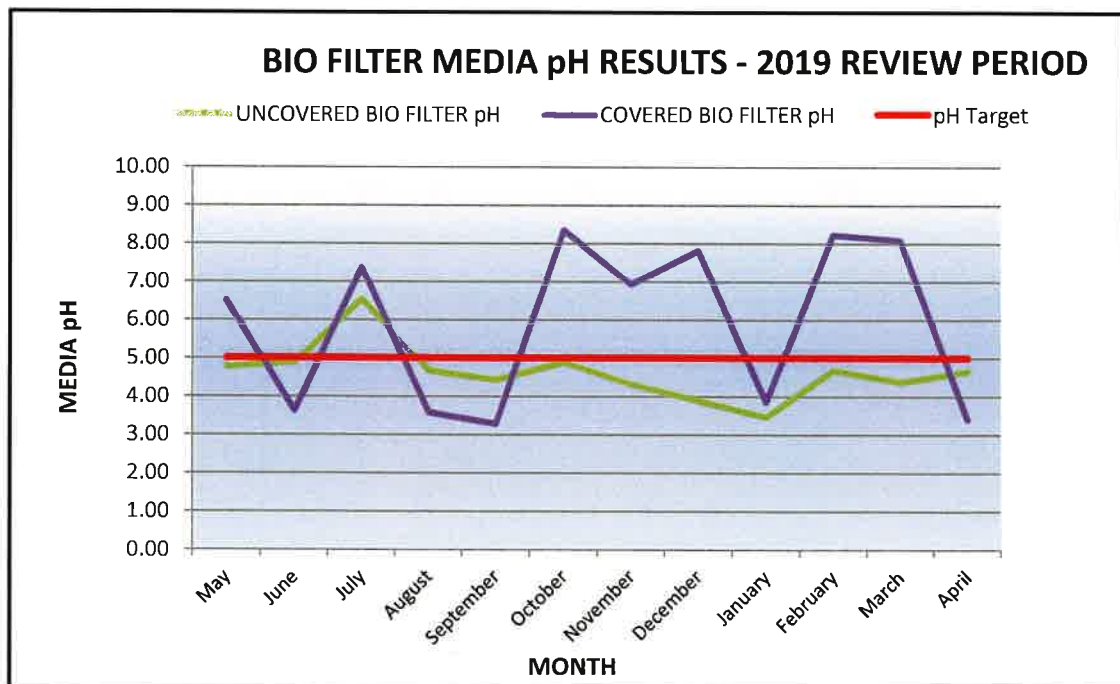
Bio-Filter Moisture and pH Graphs for the report review period:-

As per last review period pH levels obtained via Asurequality testing are very inconsistent. John Vickerman - KupeTech – has stated in the 2020 KupeTech Annual Report that there is inconsistency with the process (collection through to sampling). Refer Appendix 3 – 2020 KupeTech Report. **NOTE:-** KupeTech findings for all samples taken to date have been compliant for pH.

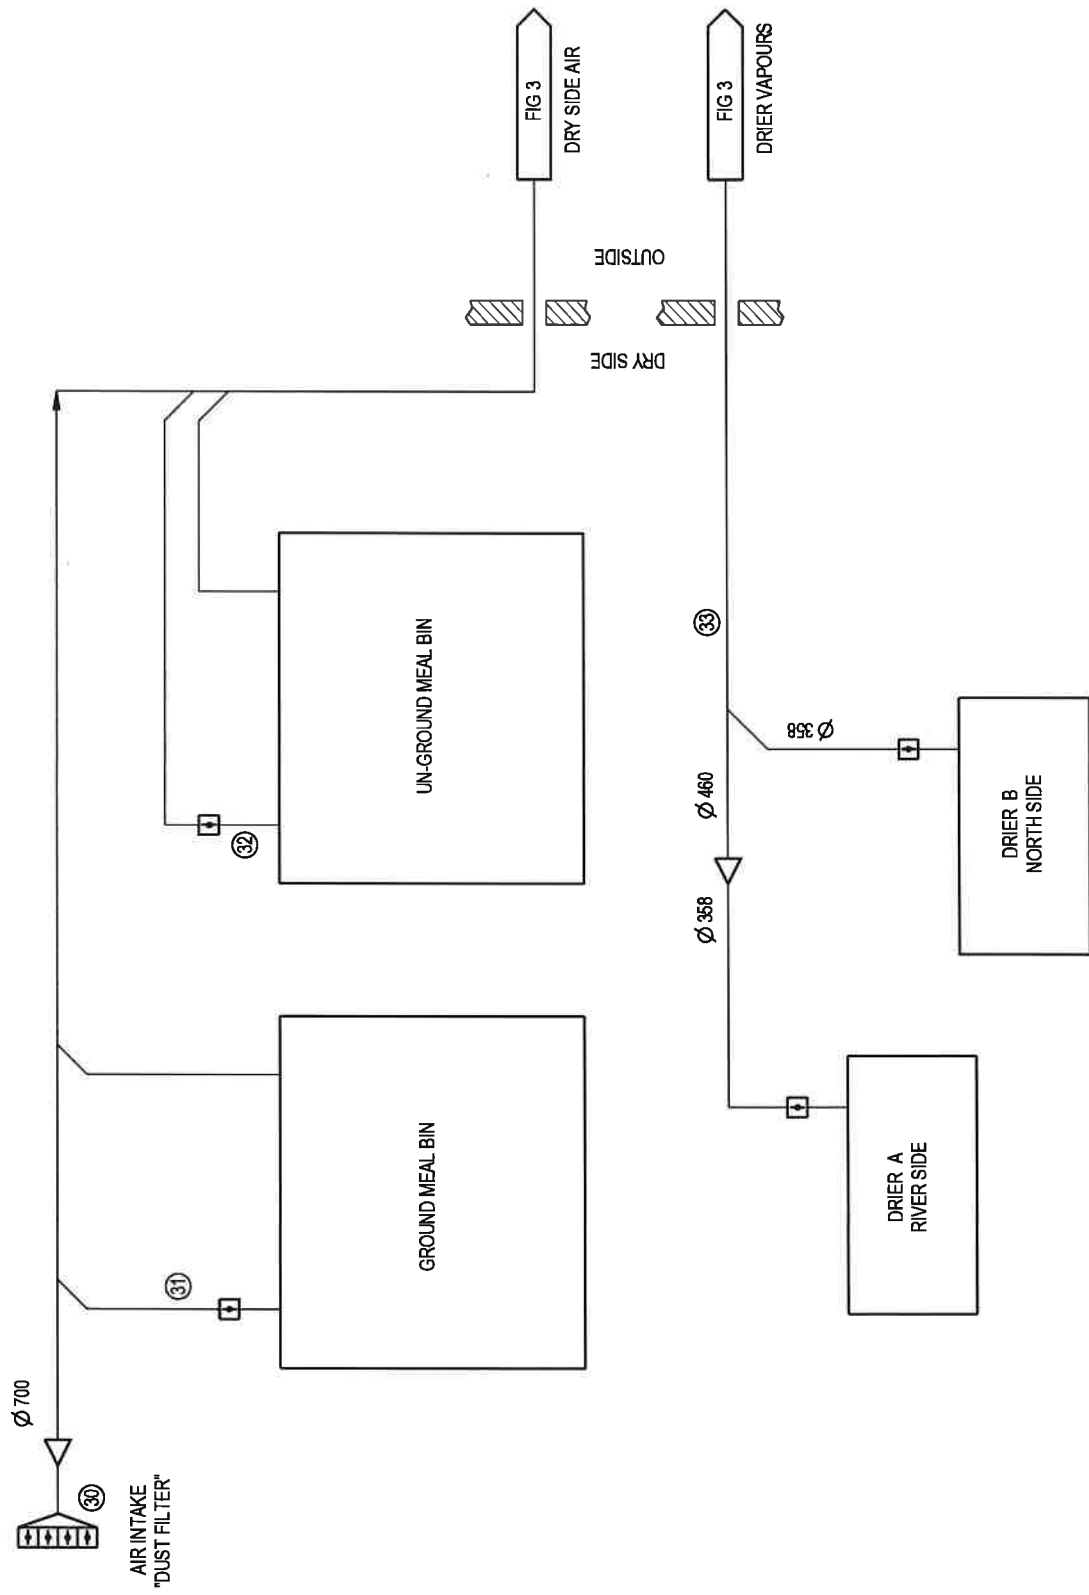
Fig 2. Dry Area Point Source Extractions at AFFCO Imlay Plant Feb 2020

- q) **Dry-side Air Intake (30 Fig 2):** Unlike 2019 when the intake was found significantly blocked, the screen was relatively clean. Air extraction was measured at 9,100 m<sup>3</sup>/h and vacuum at port 30 was 64 Pa. Flow recommended in the consent application was 5,000 m<sup>3</sup>/h, but with the building roof fan ventilation system no longer being used - to aid negative pressure in the processing areas - the higher air extraction to the biofilter is needed. Table 4 provides a snapshot of what the building working environment was on 12 February. Noted sources of heat in the dry area were the uninsulated sides of the driers; open screening of the meal and sides of the meal storage bins. The marginally highest measured temperature was air being drawn into the air intake. Although the intake is not located at the highest point in the dry area, a convective flow pattern must be carrying warm air down towards the intake. The 3,100 m<sup>3</sup>/h balance known to be coming from the dry-side will be from the un-ground and ground meal bins, some of which will be air drawn up the conveyors.

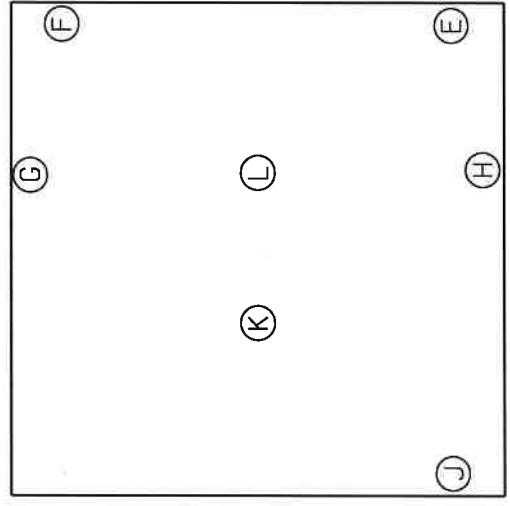
Fig 4b. Uncovered Biofilter Test Port Locations

There is another aspect to be considered that with such large surface area and small depth there is obvious variation in permeability across the bed. Varying bed pressure drops at different bed locations (Table 2 (J) and Fig 4b) are indicative of this (but these could also be indicative of a potential distributor design issue). Variation in water vapour emission in cool early morning air can also be observed. The permeability variation gives a loading that is higher in some parts and less in others. With increased bed depth, the variation in permeability would be reduced.

The air static pressure at the new test point downstream of the 14.1 fan has increased to around 520 Pa from last year but is to be expected from bed breakdown and compaction. Bed pressure drop at the five biofilter manometers (identified in Fig 4b) ranged from 5 to 44 Pa. This has increased slightly since 2019 but is still low.

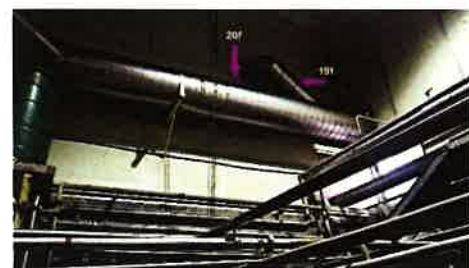
113: Wet-area north-west

| 12 | Flow measurement platform for wet area big ducts | Platform with ladder access and flow measuring ports where big wet area ducts penetrate north wall would be helpful but does not look practical given the congested piping in the area. | The photo 113 to AFFCO (in 2019) identified locations for new ports 18 and 19 except these are now shown as 20f and 19f in the photo and Fig 1. Difficulty of installing ladder and small platform recognised. New flow ports as in items 35 to 37 below would be of more immediate benefit for balancing flows and are more accessible. | |

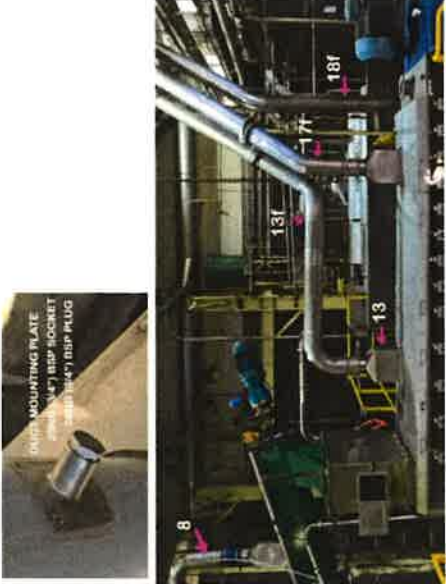
| No | Item | Issue | Responsibility | Target Date |
|---|---|---|--|---|
| 4 | Squeeze Press | Squeeze Press flow measuring ports required. | <p>New 101 type ports needed at locations 13f, 17f and 18f.</p> | Post COVID-19 |

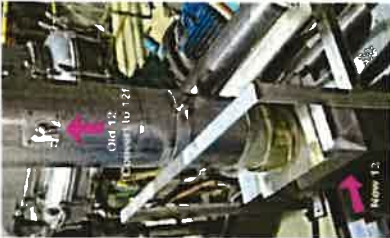
| 5 | Separators - solids conveyo flow measuring ports | Squeeze Press flow measuring ports required. | <p>New 101 type ports needed at locations 12f and 16f.</p> | Post COVID-19 |

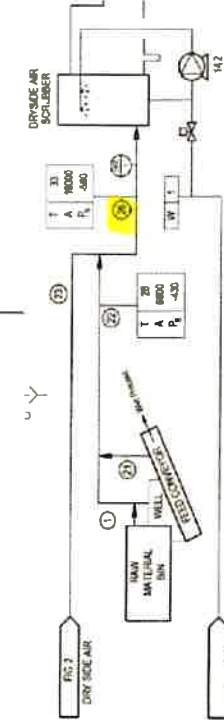
| <p style="text-align: center;"><b>9</b></p> <p style="text-align: center;">Scrubber Air Flow Measurement</p> | <p>Temperature gauge port on inlet bend currently used but error seems likely due to flow variation at bend. Two 20BSP capped ports at right angles upstream of the outside raw material bin entry duct would greatly assist flow measurement. A small length of walkway at higher level giving access to both outside raw material bin extraction duct and dryside duct for flow measurement would solve issues 21 and 22. If this is able to be done the flow measuring port in the raw material bin extraction air duct would be put in the top side of the duct.</p> <p style="text-align: center;"><b>FIG 3</b> Rinfiltair Systeeme of AEECC Inflow</p> | <p><b>Photo 101 type, Port 23 Fig 3 installed in bottom of duct. Good location for flow measurement but no platform to access port direct. Has extension piping for static pressure measurement and this was useful. Need to consider how Ports 22 and 23 can be safely accessed Temp support or permanent). Need 2 x Type 101 Photo ports in next metre segment back (upstream) from the temp gauge and HRT1. This location 26 in Fig 3. One port is needed on the same side of the bend as the temp gauge and the other port is at 90degs to it on the outer side of the bend segment.</b></p> | <p style="text-align: center;"><b>101 Type Port</b></p> |

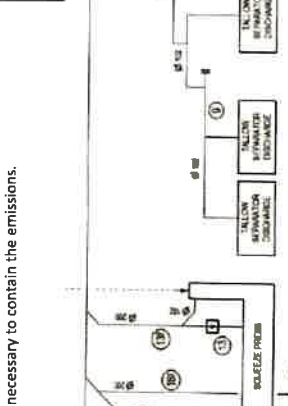
| <p style="text-align: center;"><b>10</b></p> <p style="text-align: center;">Wet Side Extraction Air Temperature</p> | <p>Temperature has crept up and little margin to biofilter max temperature remains at daily peak. Need to get accessible plugged 20 BSP flow measuring ports installed in extraction ducts with hot emissions to accurately and repeatably determine the minimum extraction flow necessary to contain the emissions.</p> | <p><b>New ports 3f and 14f (Fig1) installed. Flow measurement has enabled hot emissions to be reduced. Scope for further reduction but want flow measurement on other hot sources:- BOX WALL:- (NEW 12f); ABOVE BRANCH FROM SEPARATORS JOINING DUCT (NEW 16f)</b></p> | |
