AFFCO IMLAY

**ANNUAL AIR
DISCHARGE
MONITORING REPORT –
2020 / 2021**

AIR DISCHARGE PERMIT:-
ATH-2007010926.01

1 MAY 2020 TO 30 APRIL 2021

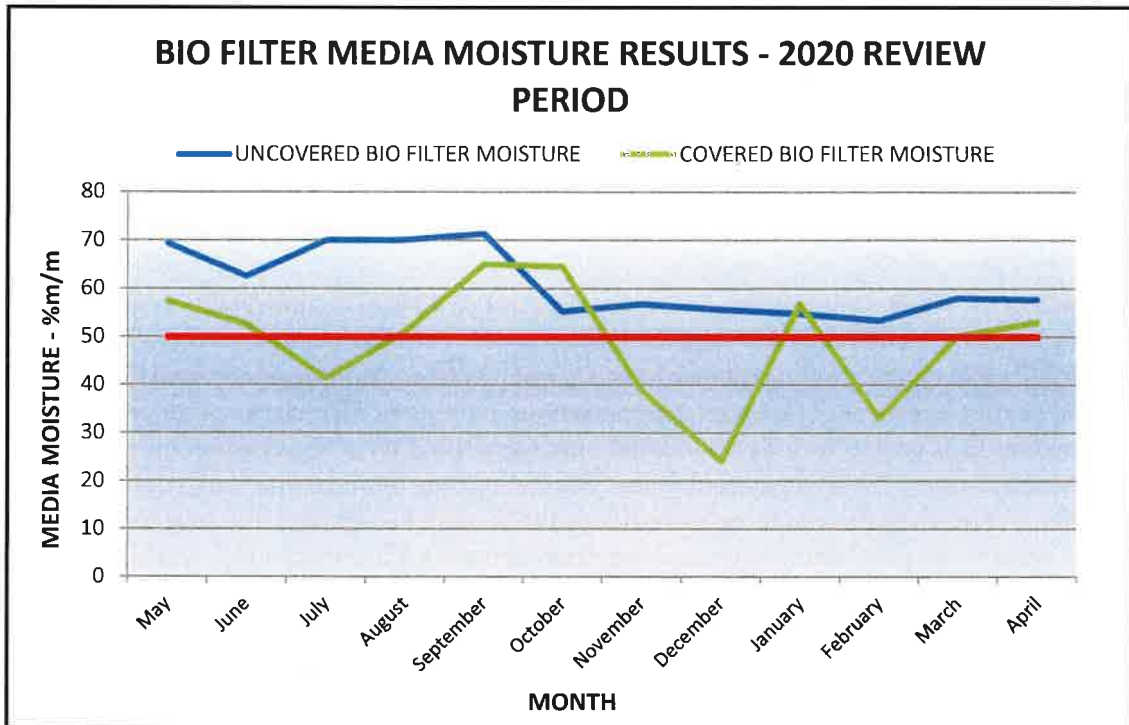
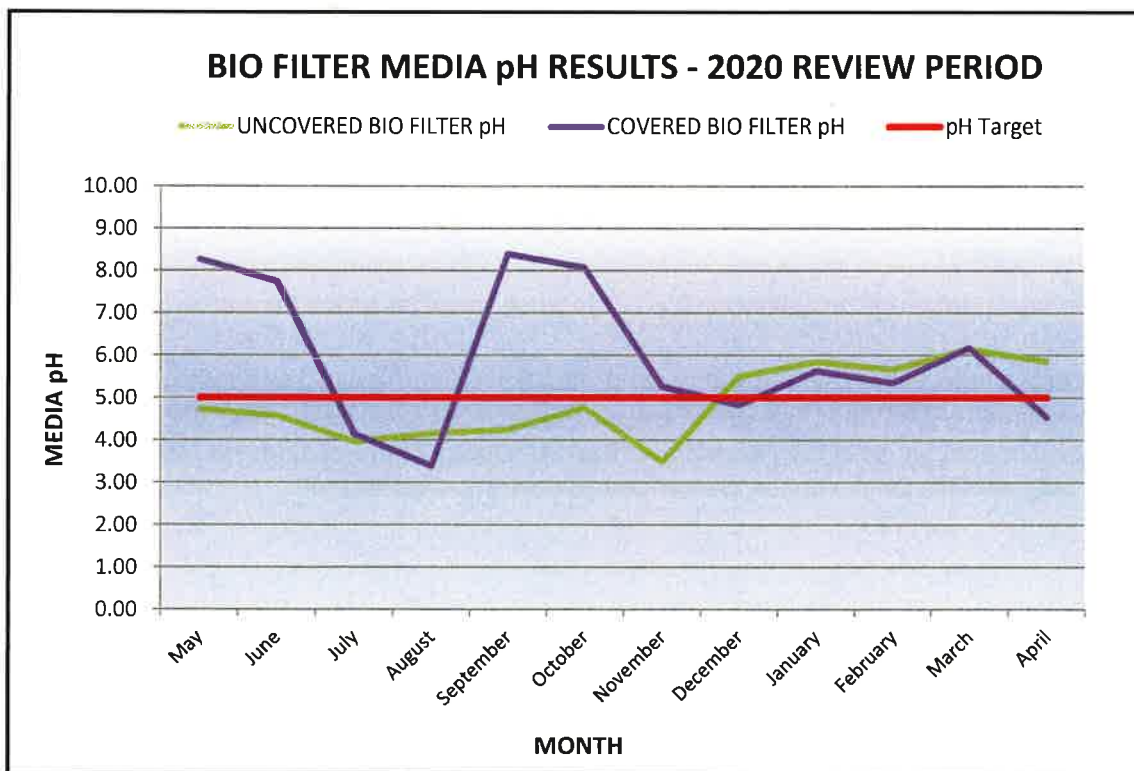
Bio-Filter Moisture and pH Graphs for the report review period:-

John Vickerman - KupeTech – has stated in the 2021 KupeTech Annual Report that at present there are no issues with pH in both biofilter beds.

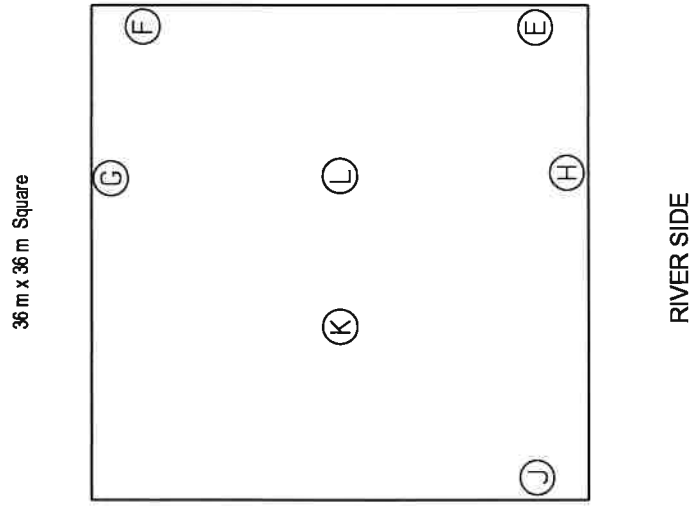
Fig 4b. Uncovered Biofilter Test Port Locations

The air static pressure at the test point downstream of the 14.1 fan is around the same as last year at 512 Pa. Increased pressure drop that would come from increased bed depth has been offset by lower pressure drop due to lower air flow. Bed pressure drop at the four biofilter manometer points F, G, H, J (Table 2, identified in Fig 4b) ranged from 15 to 31 Pa which is much the same as last year and is still low compared to many biofilters. As mentioned above point E is higher at 56 Pa but is still low. In 2017 when all the biofilter media was replaced two vent tubes K and L were installed, apparently to indicate when bed pressure drop gets too high by venting air. There was no observable flow from these and when sealed off the respective pressures at the vent tube ports were 26 and 20Pa.

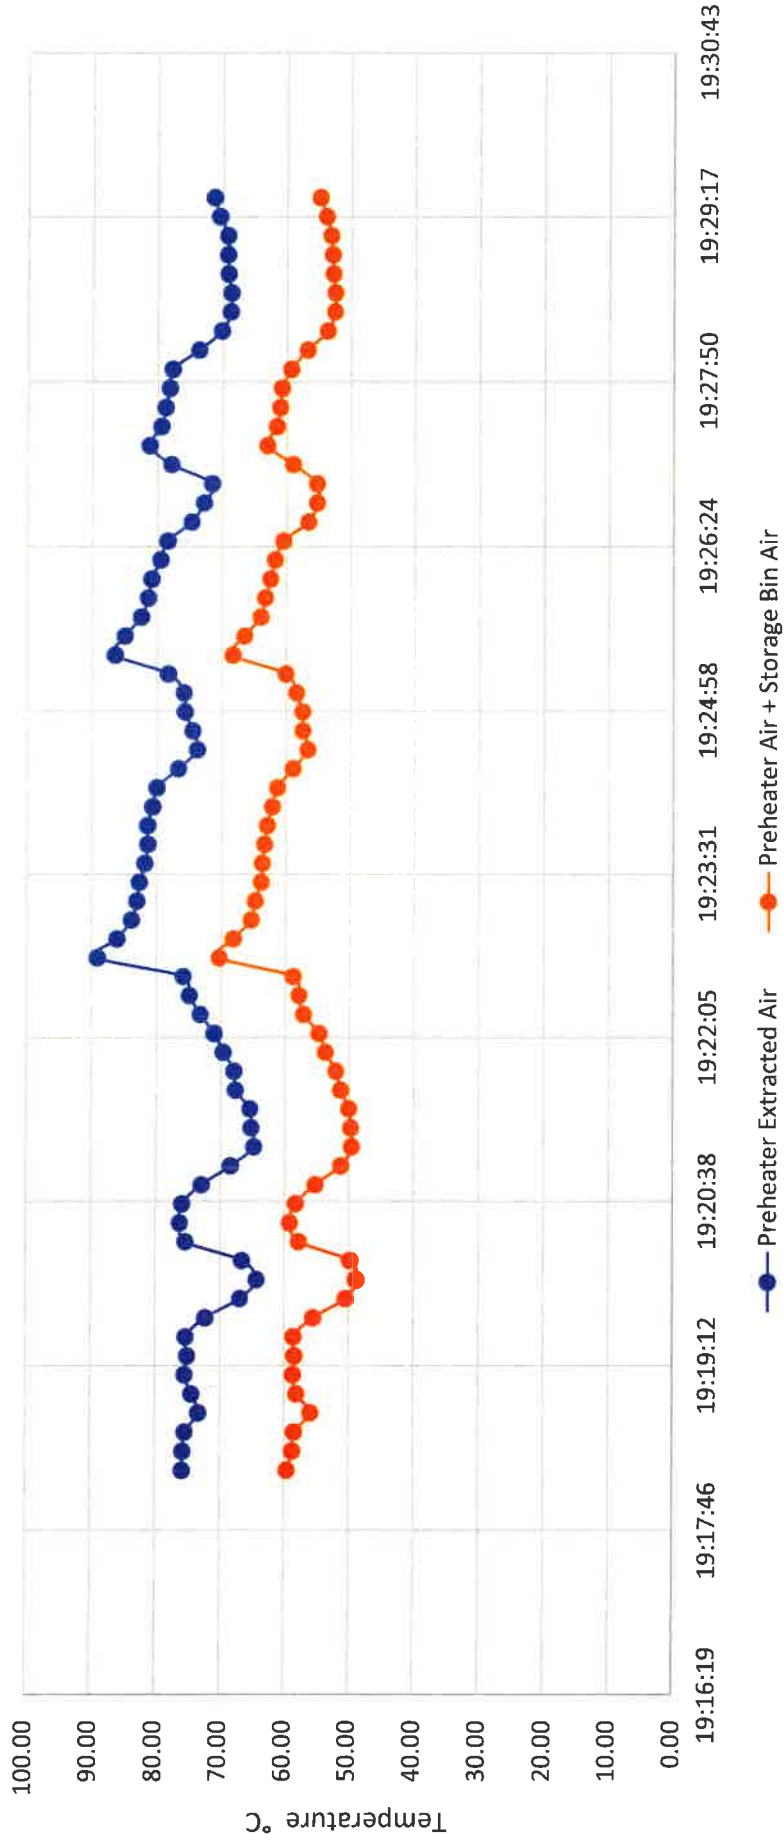
Fig 5A. Preheater Steady Heavy Throughput

After the recent balancing work limiting the preheater air extraction flow to 950 m³/h there was no indication of any backflow to the inside bin, but to further investigate what was happening the temperature of the air extracted from the preheater (at Port 3, photo 105) and the downstream temperature of air when combined with that from the inside bin (at 'Chnl 2 temperature logging location' marked in photo 105) was simultaneously logged at 20s intervals. Results for the normal steady heavy throughput condition are shown in Fig 5A. Results for the varying light throughput condition are shown in Fig 5B. In the varying light throughput run the two highest peaks at Port 3 reached 99.22 and 99.86°C respectively whereas the max heavy load peak was only 89°C (it is noted that the heavy load monitoring period shown should have been much longer like the one for varying light load, but it was a preliminary investigation and already late in the day - the heavy load pattern illustrated in Fig 5A had been like that for hours prior.) Atmospheric pressure at the time of the varying light load measurement was 101.5 kPa and taking account of slight vacuum in the duct and slight building under pressure, the saturated steam temperature at 101.44 kPa would have been 99.99°C hence the 'air' being extracted at these peaks would have been almost entirely steam.

- 4 Airflow from preheater has been restricted to give a flowrate around 950 m³/h. Hot vapour from preheater may briefly backup into feed conveyor at 55-65 Pa when feed commenced after pre-heated no load or varying light load. No backup at other times like under full load. See Figs 5A and 5B for datalogged temperatures.

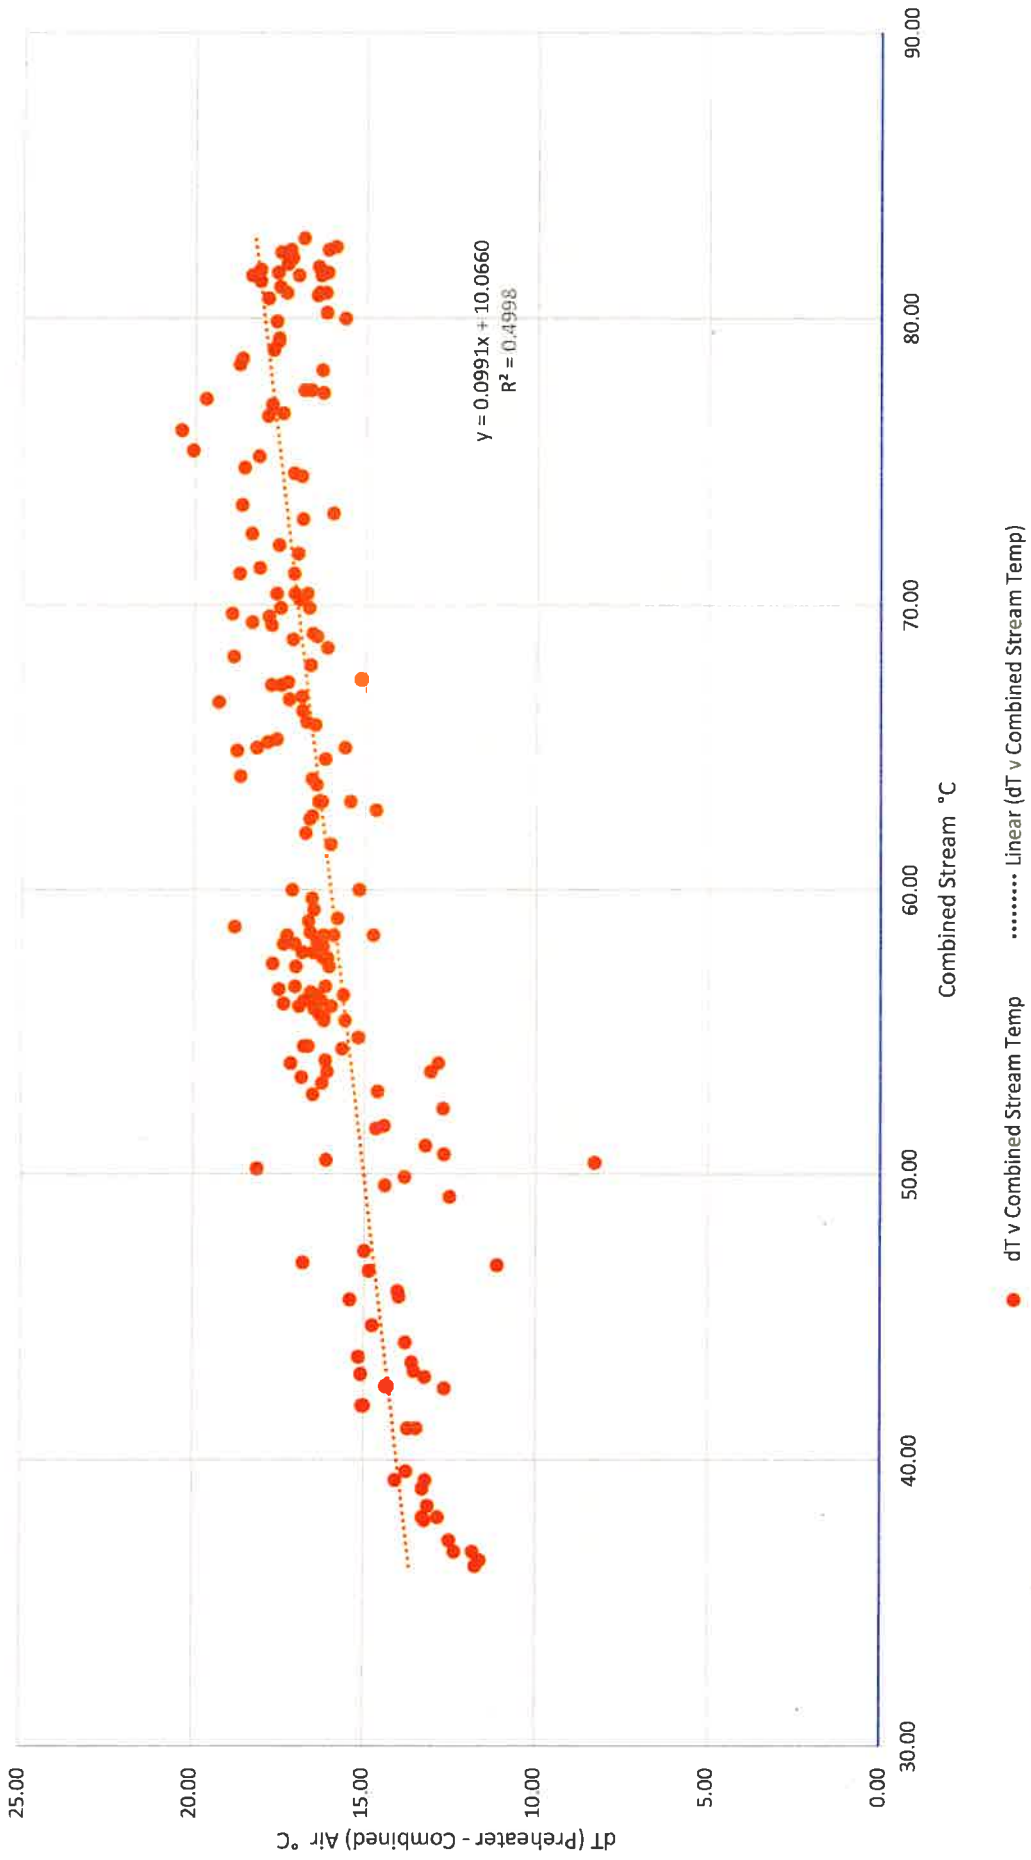
Fig 5C. Preheater Light Load dT v Combined Stream °C

Fig 5C was produced from the logged data by plotting the difference in temperature at the two measuring points against the combined stream downstream temperature. The linear trend line of these plotted points shows that with increasing downstream temperature, the difference in temperature measured at the two points increases. If the steam from the preheater was building up to the extent that it was back flowing to the ground material bin, the difference in temperature would decrease with increasing temperature and eventually both measurements would be the same. Hence there is a high level of confidence that no back flow to the ground material bin is occurring as it had been prior to the flow adjustment. A further point is that with the peak temperature events the air flow to the biofilter increases. Unlike the choking effect of drier steam in the evaporator when there is no circulating stickwater to condense it, with the preheater steam it does condense by transferring heat to downstream air drawn into the extraction duct along the way. The steam which is drawn into the extraction duct from the preheater disappears as it heats further air along the duct allowing more air to be drawn in under the differential pressure conditions.

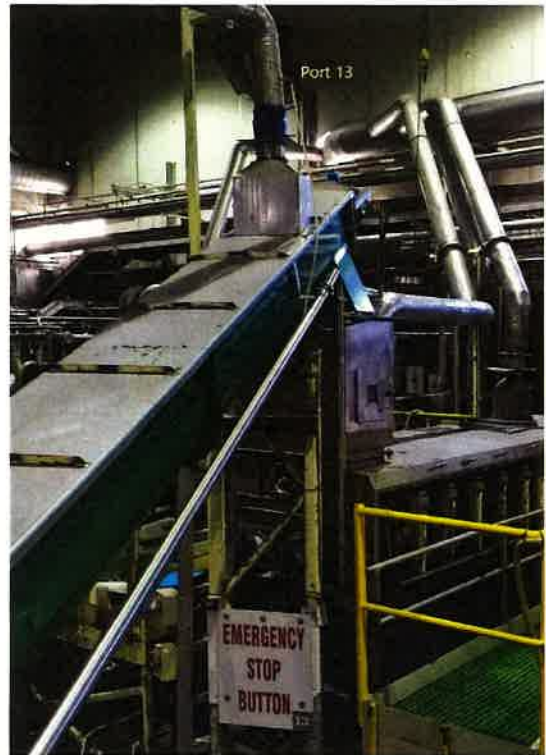
115: Port 11 – Inlet conveyor to Driers

- m) **Drier Feed Conveyor (Port 11):** The new flow measurement and pressure monitoring port 11 is marked in Photo 115. A tube extends from the tube fitting enabling the static pressure to be measured at ground level. The audit measurements were made direct at the port. Air flow was found to be 850 m³/h and static vacuum at the port was 116 Pa - vacuum at the end of the tube extension should be at least 100 Pa. In Photo 115 a corroded slot can be seen in the extraction box mounting flange. This hole was used to establish vacuum in the conveyor headspace around 20 Pa. A 6.5 mm hole like that for port 6b seen in photo 108 would be helpful to consistently measure headspace vacuum. If the corroded slot is occasionally used to establish whether solids are moving or not, a simple hinging flap could still provide that function while most of the time blocking around 250 m³/h of air that is being drawn into the slot.

- 12 Measured at new Port 11 (see photo 115) . This extraction duct draws air from the driers feed cross-conveyor - both driers were operating and there is headspace for air to be extracted from the south end. From previous air flow measurement prior to installation of the duct port 11 air was being drawn from the cross conveyor between driers with practically none being drawn up from press-decanter solids conveyor discharge location.

ODOUR CONTROL SYSTEMS - 2021 ACTION LIST					
No	Item	Issue	Photo	Comments	Actions Taken
2021-5	Driers Feed Conveyor Air Extraction Duct	See photo 115. Corroded opening at base of air extraction intake box below the slide valve.

Can the opening be closed? Is the corroded slot used to check whether solids are moving in the conveyor or not? If so can a hinging flap cover the opening? Desirable to maintain slightly more vacuum in conveyor air space if possible mainly relating to what is happening at the bottom (upstream end) of the conveyor.	Completed 29.04.21
2021-6	Solids Discharge Conveyor press - decanter	See photo 122. Open slot draws in 130 m ³ /h air. A 2020 photo of the same equipment does not have the gap. Has the conveyor cover plate been intentionally assembled in the wrong position? Is this slot used to view movement of solids in conveyor? Can the slot be covered?

An objective is to increase vacuum in the conveyor but constraints on further slide valve adjustment at 12e and 12w are still being investigated. In the meantime any elimination of unneeded openings in the conveyor covers will help.	Completed 29.04.21

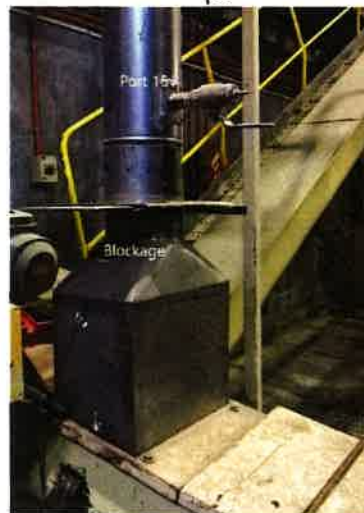
119: Port 15 - Driers Discharge Conveyor

- p) **Drier meal discharge conveyor duct (15):** In 2019 the duct had been disconnected from the conveyor and an airflow into the duct was measured at 500 m³/h. With reconnection, Port 15 (photo 119) was added. Recent flow measurement gave only 50 m³/h. Static vacuum at Port 15 was 435 Pa but as best could be ascertained the vacuum in the conveyor head space was only 15 Pa (a small hole in the duct transition box like 6b in photo 108 would have helped). Complete removal of the valve slide made no difference to the flow and pressures hence it is concluded that there is a bridge of meal across the top of the duct transition box below the slide valve. This is not seen as a major issue as air in the conveyor will be drawn to extraction in the unground meal bin. In hindsight this blockage is likely not the first time so ease of clearing it might be considered in disassembly/reassembly.

<i>Supervisor - Mike Rennie - advised to monitor during daily monitoring checks. Completed March 2021</i>
2021-4	Driers Discharge Conveyor air extraction duct entry box	See photo 119. Pressure and flow measurements indicate that a bridge of meal must be almost completely blocking the duct below the slide valve. Removal and replacement of the slide valve makes no difference.

This may have been an issue in the past as it would explain why this extraction duct has been disconnected at times. Absence of extraction air at this location is not viewed as a significant source of odour as air in the conveyor is still likely to be drawn to the unground meal bin. Clearance of the blockage and a largely closed slide valve (to keep the air velocity in the transition box low) is recommended until further flow measurement and slide valve adjustment made.	<i>Supervisor - Mike Rennie - advised to clean chute. Target date for cleaning 17.05.21</i>

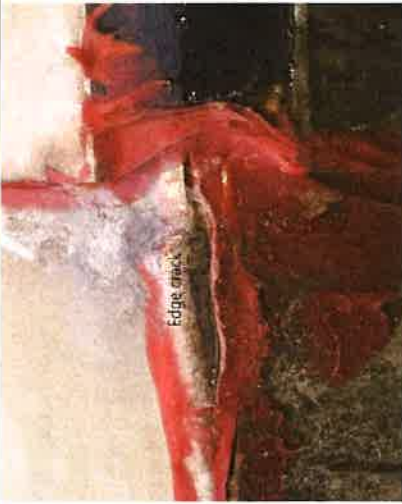
ODOUR CONTROL SYSTEMS - 2021 ACTION LIST					
No	Item	Issue	Photo	Comments	Actions Taken
2021-3	Fan 14.1 Discharge transition duct crack sealing	See photo 103. The crack is currently well sealed but likely to open with ongoing fan vibration. Ongoing vigilance for leaks between fan and biofilter is needed.
