**AFFCO IMLAY**

**ANNUAL AIR  
DISCHARGE  
MONITORING REPORT –  
2018 / 2019**

**AIR DISCHARGE PERMIT:-**  
**ATH-2007010926.01**

**1 MAY 2018 TO 30 APRIL 2019**

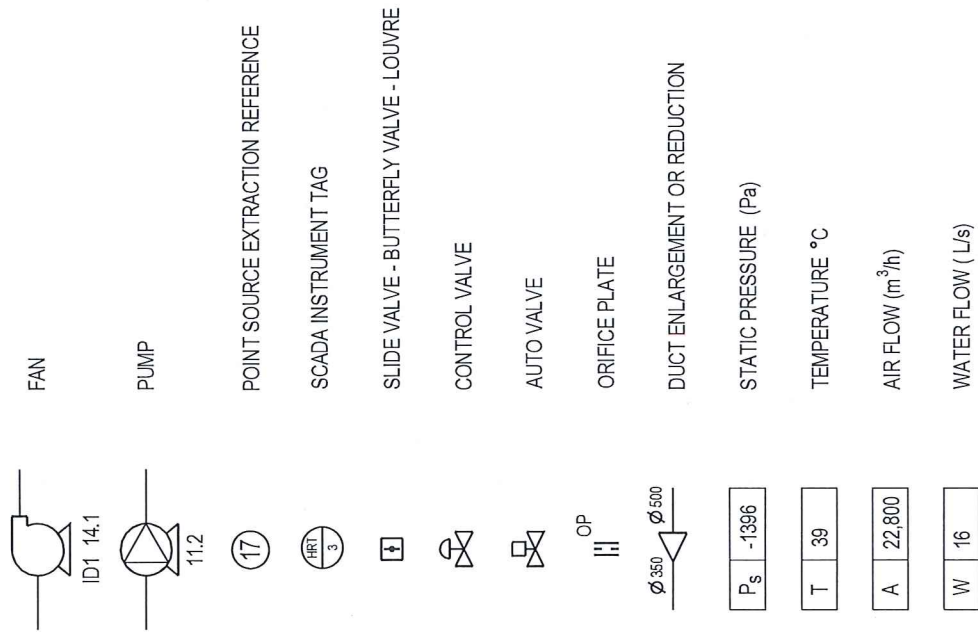
Fig 3. Biofilter Systems at AFFCO Imlay Plant April 2019

Figure 3 provides a schematic of the outside dry side, wet side and drier air extraction systems feeding the biofilters. Typical air flows in m<sup>3</sup>/h, static pressures in Pascals (Pa) and temperatures in °C are given in a few locations. Tags for some instruments in the SCADA system are also given for reporting reference.

- e) Dry Side air passes through a spray tower (Dryside Air Scrubber in Fig 3) to a common induced draught fan 14.1 (was also known as ID1) which discharges into the uncovered biofilter. The primary function of the spray tower is to remove dust particles and protect the biofilter from clogging. Cooling and humidification are other benefits. Air extraction from the outside raw material bin (point source 1) and feed conveyor is also combined with the inflow to the scrubber.

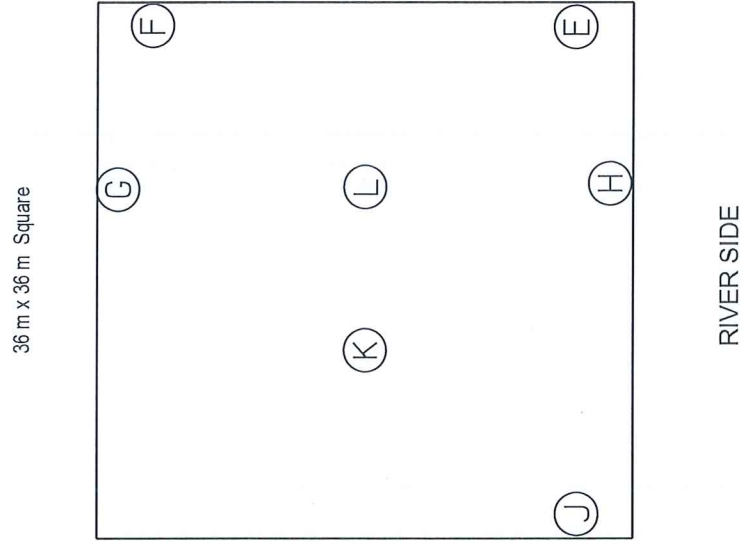
Fig 4b. Uncovered Biofilter Test Port Locations

Fig 4b provides a diagram showing the static test port locations on the uncovered biofilter.

The air static pressure at the new test point downstream of the 14.1 fan has increased around 30% to 300 Pa from last year but is well below earlier years. This is related to the renewed biofilter media. Bed pressure drop at the five biofilter manometers (identified in Fig 4b) ranged from 6 to 34 Pa. This appears to be slightly less than a year ago but it likely related to having a better instrument to measure the low pressure.
